Erosion from Sinkhole Closes State Route 35 In Rural San Mateo County

Updated: March 15, 2019

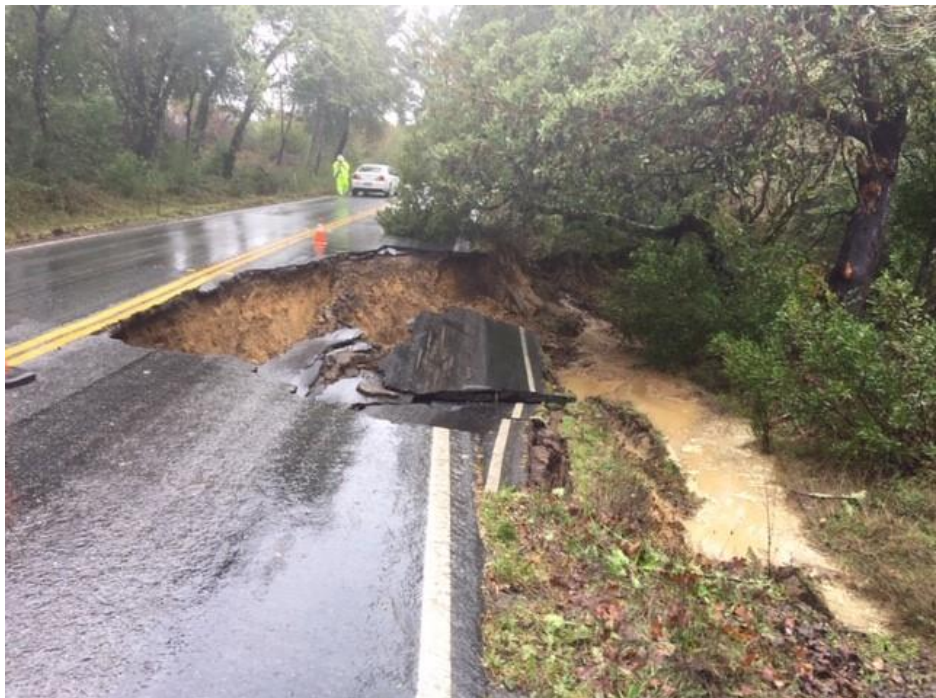
A sinkhole on State Route 35, also known as Skyline Boulevard, in rural San Mateo County caused Caltrans to close both directions of the two-lane highway on Sunday, February 3, 2019. Within two days the pavement on northbound lane of Route 35 had sunk six-feet below southbound lane. The road remains closed.

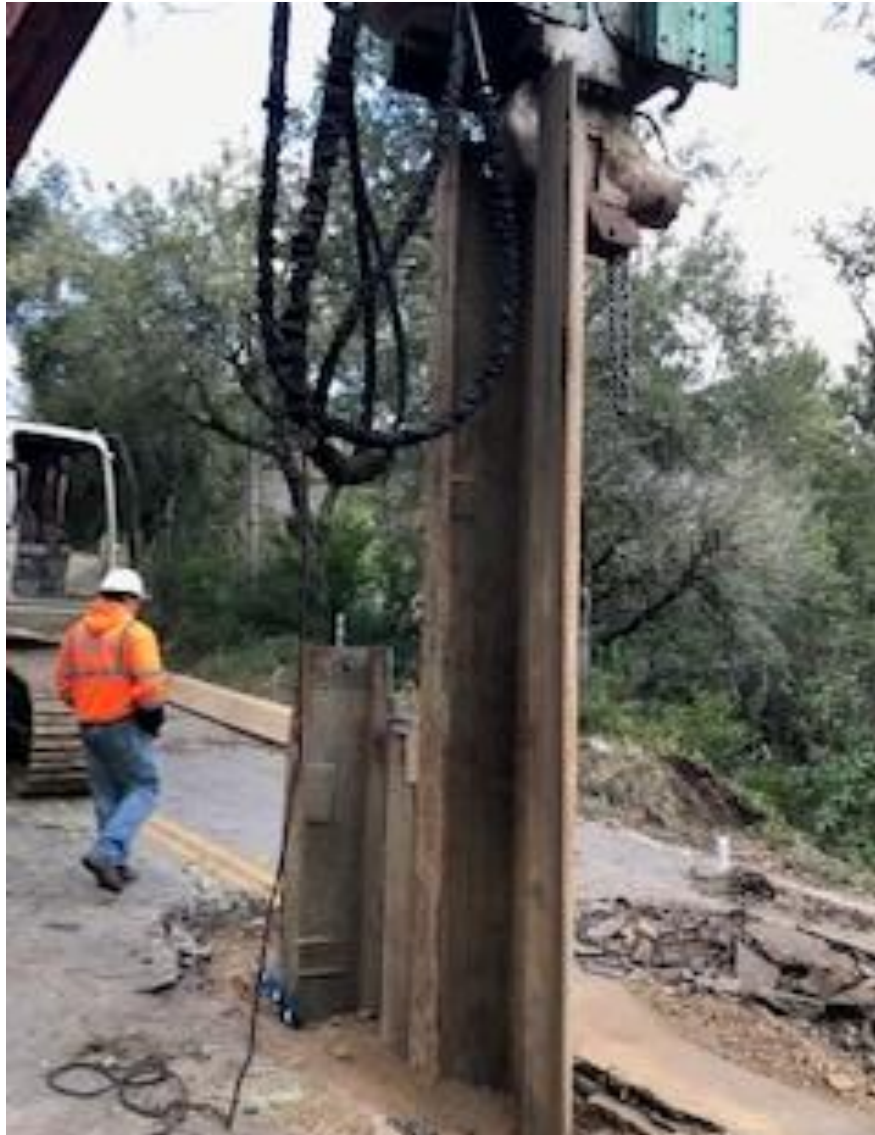
Sheet piles being driven into the ground near the centerline. The interlocking piles will form a subsurface retaining wall, stabilizing the southbound lane (left). After the sheet pile wall is in place, Caltrans will widen the southbound lane, install traffic signals and open the road to one-way traffic control.

Caltrans activated an emergency contractor with Golden Gate Construction, who arrived onsite the following day. Workers began driving sheet piles, interlocking them to form an underground retaining wall that will support the southbound lane.

Two traffic signals and an electrical system have been brought to the worksite. Caltrans will assemble a traffic signal to be placed several hundred feet to the north and south of the sinkhole. Once the sheet pile retaining wall is completed, Caltrans will activate the signals for one-way traffic control.

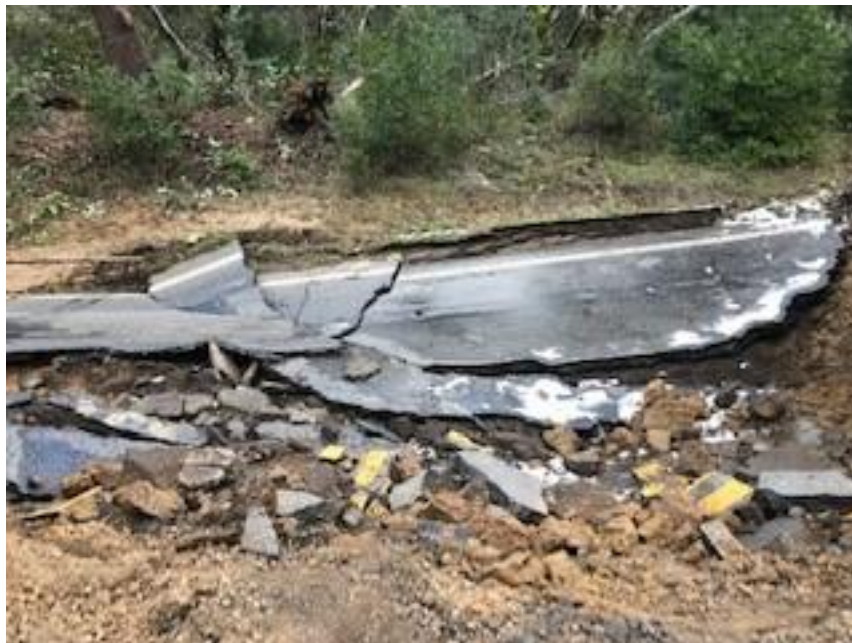
A week after the sinkhole appeared the northbound lane had completely eroded.
